Failure Simulation Testing of the Z-1 Spacesuit Titanium Bearing Assemblies

Stephen Peralta, Alfredo Juarez, Jonathan Tylka and Richard Rhodes

7/13/2016

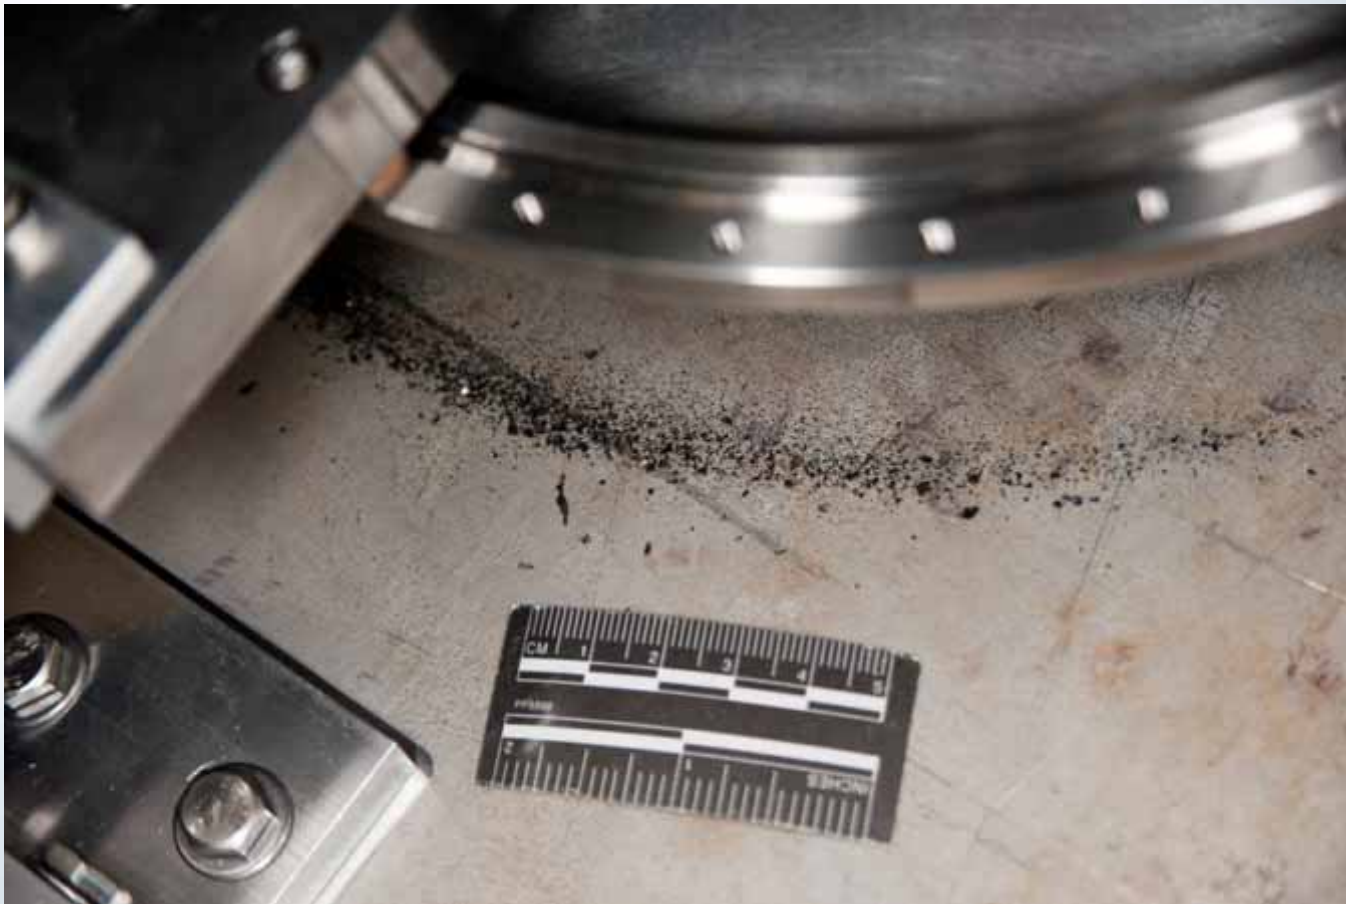
- Hip Bearing "Failure"

- Additional testing performed on a hip bearing assembly to further investigate the mechanical wear of the bearing witnessed and the effect of maintenance on the performance of the bearing.
- After the massive amounts of wear and debris seen in the hip, it was suspected that the bearing lubricant was drying out and the buildup of worn ball bearing debris was then becoming a contributing factor to the overall bearing wear.
- It is now believed that the ball bearing wear was more of a contact stress problem.
